# Field and laboratory observations of down-slope bentonite migration in exposed composite liners<sup>☆</sup>

R. Kerry Rowe<sup>a,\*</sup>, Richard W.I. Brachman<sup>a,1</sup>, W. Andy Take<sup>a,2</sup>, Amy Rentz<sup>b</sup>, Lauren E. Ashe<sup>c</sup>

<sup>a</sup> GeoEngineering Centre at Queen's-RMC, Department of Civil Engineering, Queen's University, Kingston, ON, K7L 3N6, Canada

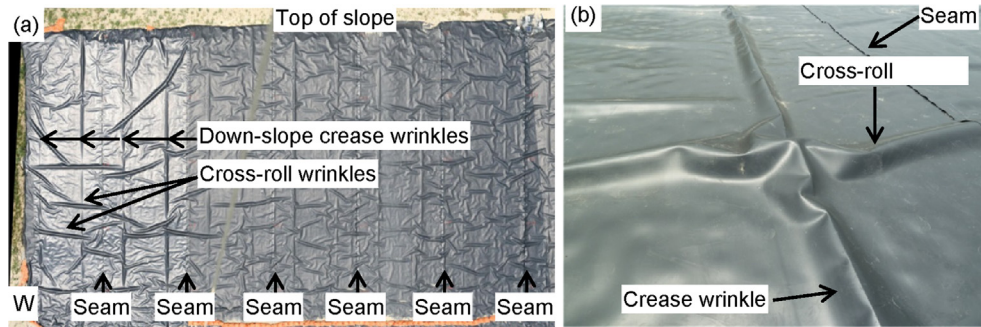
there were many cross-slope wrinkles. Some of the cross-roll wrinkles were inclined to the horizontal (Fig. 3a) and most intersected a down-slope wrinkle and/or a seam (potential drip accumulation and drop points). There were also many smaller wrinkles intersecting either down-slope creased wrinkles or seams that also were smaller sources of evaporative water.

Fig. 3. Wrinkling: (a) Aerial view of western half of slope at 12:30 on 26/7/07, and (b) Winkle intersection.

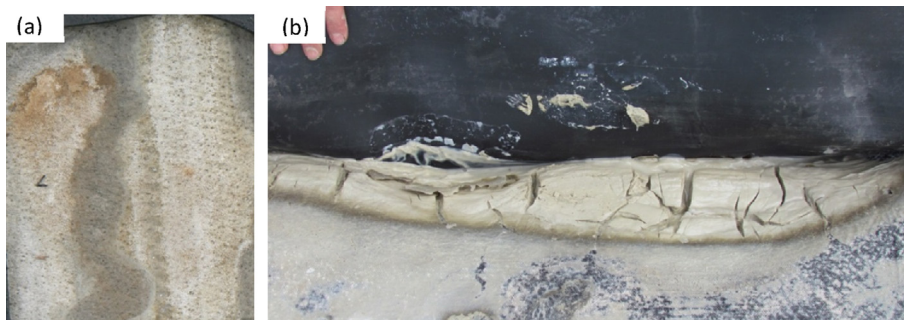
Fig. 4. (a) Rivulet meandering down-slope, and (b) accumulation of bentonite at base of GCL3a slope.

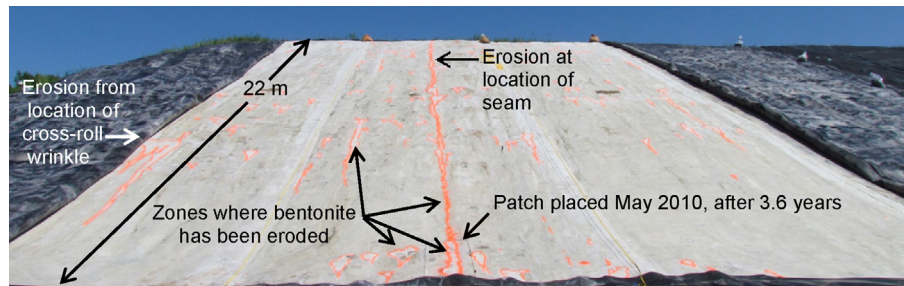
In early June 2011 (4.7 years after construction), the QUELTS I experiment was terminated with a detailed inspection of each GCL panel. Fig. 5 shows GCL2 at the western most slope section. For this GCL, likely areas where the bentonite had been washed out (eroded) were signalled by a whiter colour than the surrounding GCL. Since not all white areas were totally eroded, tactile inspection was used to confirm that an area had little to no bentonite remaining. Areas identified as having essentially no remaining bentonite were highlighted in orange paint to facilitate photography (Fig. 5). The primary erosion feature ran from the top to the bottom of the slope at the location of the western-most seam shown in Fig. 3a. Inspection of Fig. 3a shows many small and some

**Fig. 5.** GCL2 – Western-most section in June 2011 after 4.7 years on 3H:1V south facing slope. Significant downslope-bentonite erosion was observed at all areas highlighted with orange marking paint. Modified from Brachman et al. (2014b). (For interpretation of the references to colour in this figure legend, the reader is referred to the web version of this article.)

large wrinkles converging on the seam. It appears that water which condensed in these wrinkles migrated to the seam and that the seam acted as a drop-point causing water to accumulate and run down the GCL below the seam. This erosion feature was first observed when the section was opened in May 2010 and a portion was removed and replaced as discussed above. In the subsequent year, the replacement patch had also experienced substantial erosion (bottom centre of Fig. 5) indicating that substantial erosion could occur at this site in as little as one year. This feature was typically 90 mm wide but was 330 mm wide at a location where a major angled cross-roll wrinkle intersected the seam (Fig. 3a). Another significant feature was observed near the west of the first panel at the location of a cross-roll wrinkle (Fig. 5) with a long downward extension which was located below a portion of the westernmost down-slope crease wrinkle (Figs. 3a and 5). In total, 127 erosion features were detected for this one section (a feature being defined as essentially complete erosion of bentonite over a width exceeding 15 mm).

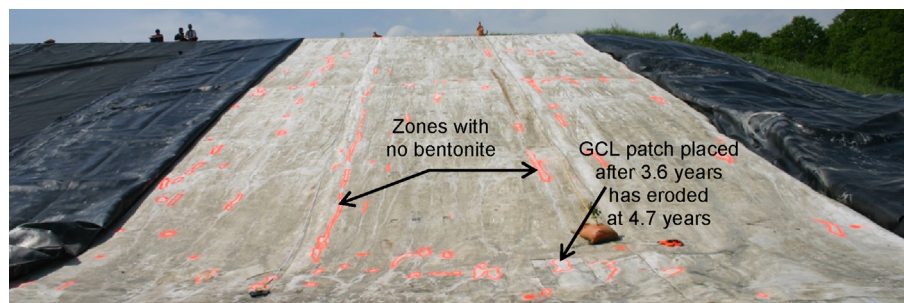
**Fig. 6.** GCL3b placed with white nonwoven cover facing up in June 2011 after 4.7 years on 3H:1V south facing slope. Areas of significant bentonite erosion highlighted.

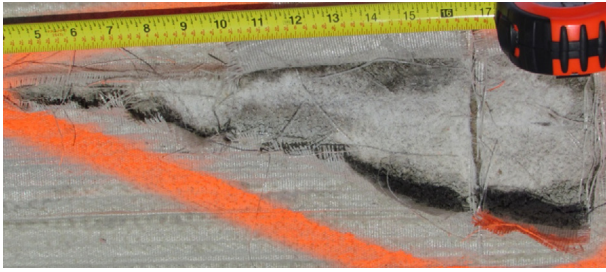
**Fig. 7.** Erosion feature identified by tactile inspection and then destructively inspected to confirm bentonite loss. Photo has been rotated 90°. 140 mm wide loss of bentonite at right of photo was upslope and the feature narrowed over its 420 mm length running down the slope (right to left).

the GCL at areas of potential erosion (Fig. 7). In this case, the number of erosion features identified was about 30% of that found with the white nonwoven cover of GCL2 facing upward. Nevertheless, as for GCL3a with the woven up, GCL1 had sufficient significant eroded features (the largest being about 200 mm wide and 1000 mm long) that, after 4.7 years of exposure, would compromise its effectiveness as a hydraulic component of a composite liner. The fact that it was much more difficult to identify erosion features with the off-white woven up than with the nonwoven white geotextile up was curious. The laboratory investigation described in Section 3.3 below provides insight into this matter.

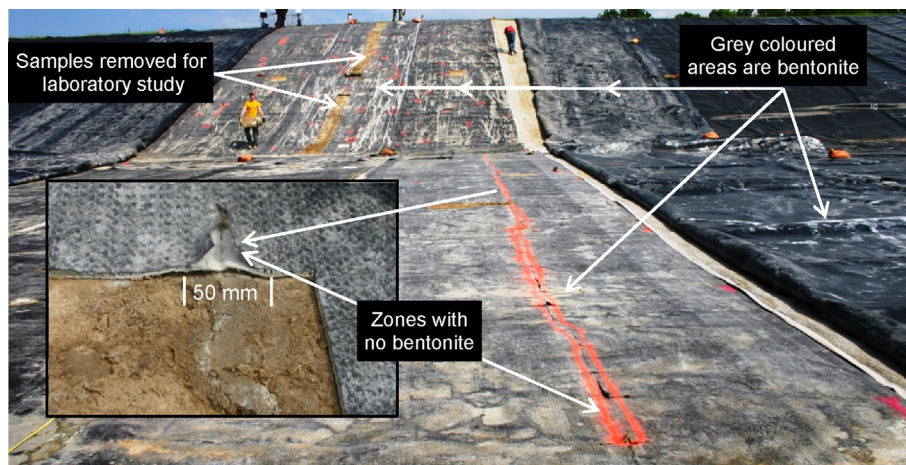
**Fig. 8.** GCL4 on the 3% sloping base in the foreground (showing that, given enough time, erosion can occur even on a small slope) and on the 3H:1V slope in the background. After 4.7 years, an extensive (18 m long) zone with no bentonite is highlighted on the right-hand base panel. Light grey areas are bentonite deposited on the black geotextile or adhered to the bottom surface of the geomembrane.

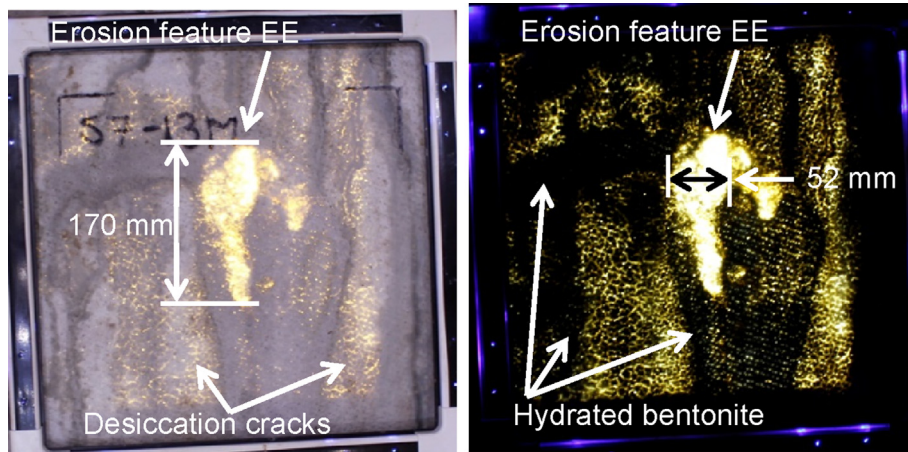
**Fig. 20.** Photographs taken in field dark room (Fig. 19) on 27 May 2013 (i.e., 1 year after construction of QUELTS II) at a location 13 m down the slope on Section 3 (GCL2 below black geomembrane) showing an irrecoverable erosion feature that had developed at this time. Areas with no light shining through are hydrated bentonite. Dappled areas are locations where there is bentonite and the light is shining through desiccation cracks that will self-heal on hydration.

With the LED light on, two photographs were taken: (a) one with an internal light in the dark room turned on (Fig. 20a), and (b) one with the internal light off (Fig. 20b). The photos in Fig. 20 show an irrecoverable erosion feature (EE; width > 25 mm) that is 52 mm wide at its widest and 170 mm long that has developed in the 12 months since QUELTS II was constructed. This is consistent with the observation of extreme erosion (and irrecoverable erosion) observed at QUELTS I on patches placed after 3.6 years and inspected at 4.7 years discussed earlier (Fig. 5). There is a second erosion feature developing to the right of the main feature in Fig. 20 and it appears that, with more time, they may connect. Also evident in Fig. 20 are areas of hydrated bentonite (no light in Fig. 20a and black in Fig. 20b) and areas of previously hydrated bentonite that have dried and desiccated (dappled areas). These photographs show that for a composite liner left exposed at the QUELTS site for one year, the condition of the GCL can vary substantially in a small distance from well hydrated bentonite, to dried and desiccated bentonite (capable of self-healing when re-hydrated) to areas where there is no bentonite remaining over an area too large to be repaired by swelling of bentonite when the GCL re-hydrates.

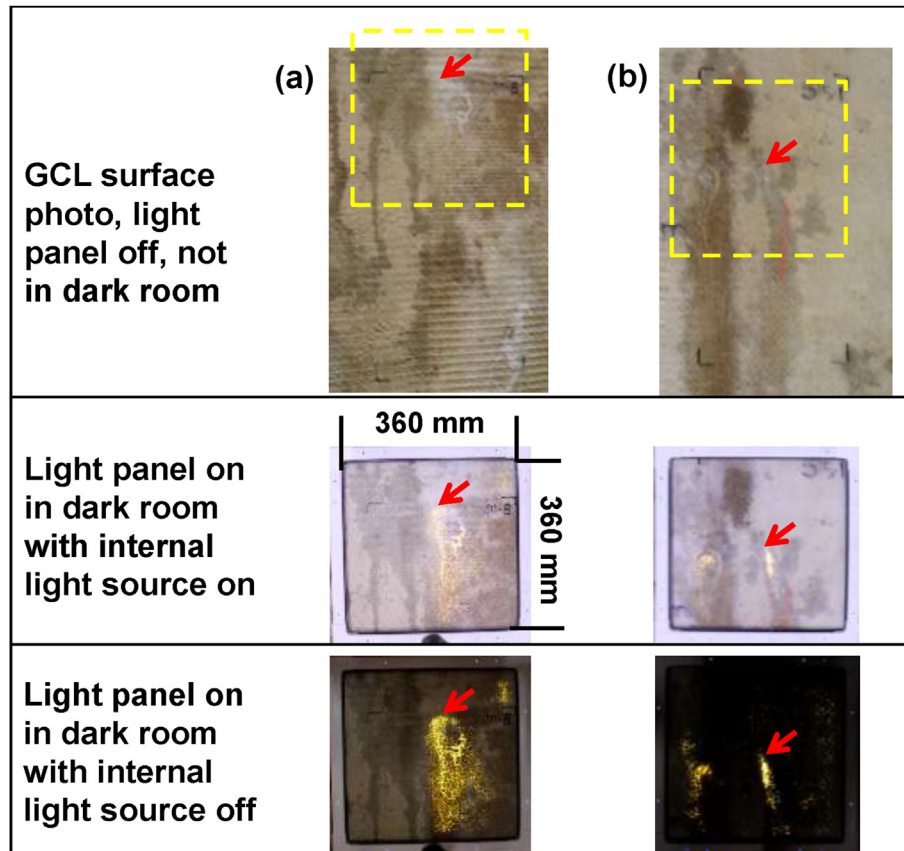
GCL5 (Section [4]) and GCL6 (Section [6]) experienced hydration and drying and early erosion ('e') features (Fig. 21), however in some cases these early erosion features observed at a given time had self-healed at a subsequent time (Fig. 22). After 28 months in the field, nothing more than an early erosion feature was observed for GCL5 or GCL6 suggesting that there was something different between the field and laboratory behaviour of these two GCLs with

**Fig. 21.** Back-lit erosion photos taken after 6 months exposure (November 2012): (a) early erosion 'e' on GCL5, and (b) early erosion 'e' on GCL6. The yellow squares are 360 × 360 mm identifying the location of inner edge of the frame shown in light panel photos. The upper photo is taken in normal daylight; the middle photo is taken from inside the portable dark-room with the internal light source on; the lower photo is taken from inside the portable dark-room with the internal light source off. (For interpretation of the references to colour in this figure legend, the reader is referred to the web version of this article.)

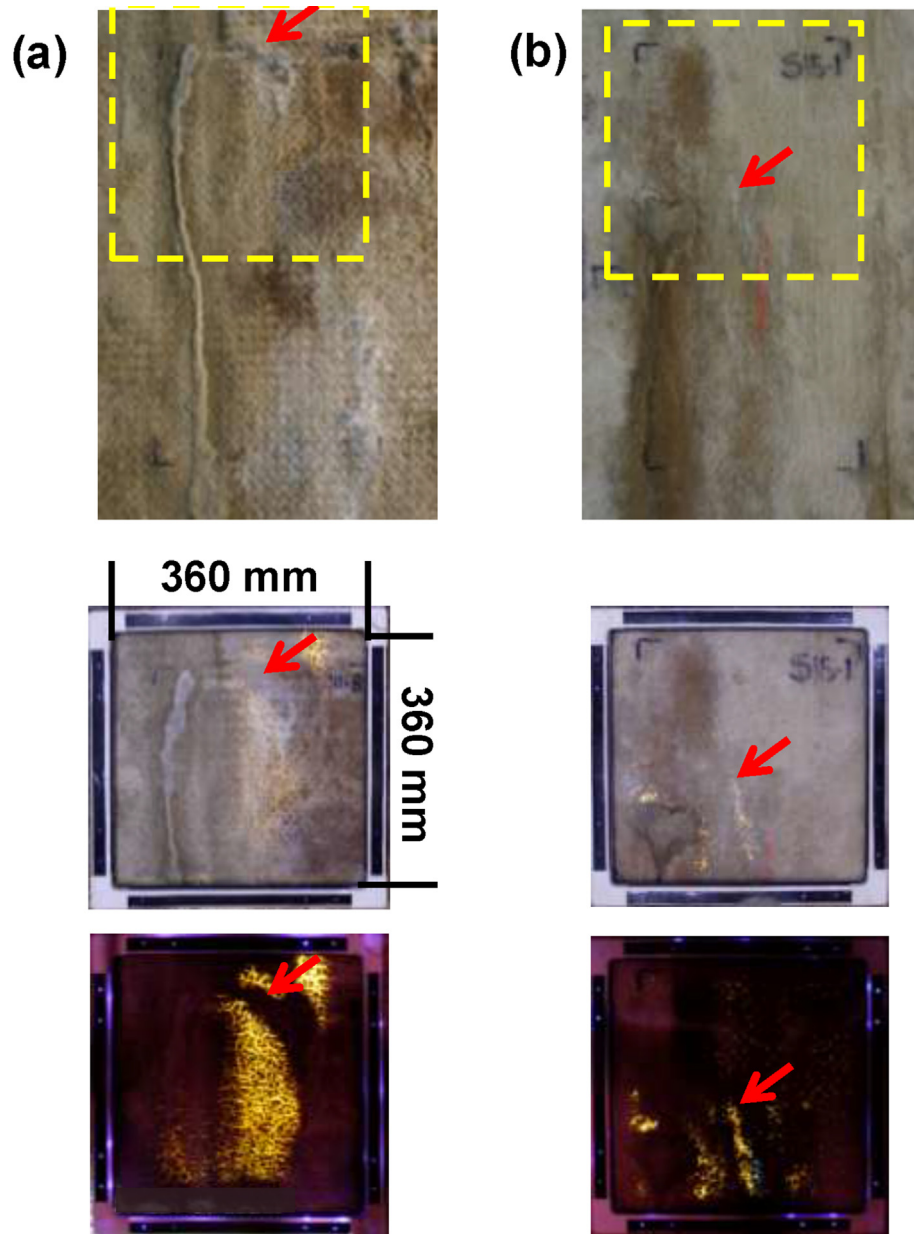
**Fig. 22.** Back-lit erosion photos taken after 12 months exposure (May 2013): (a) the feature indicated by the arrow on GCL5 was early erosion 'e' after 6 months exposure (Fig. 21a) and is now hydrated and healed at the time of inspection but a new early erosion 'e' feature has formed in the upper right corner of the framed area, and (b) the feature on GCL6 was early erosion 'e' after 6 months exposure (Fig. 21b) and is still an 'e' feature. The yellow squares are 360 × 360 mm identifying the location of inner edge of the frame shown in light panel photos. (For interpretation of the references to colour in this figure legend, the reader is referred to the web version of this article.)

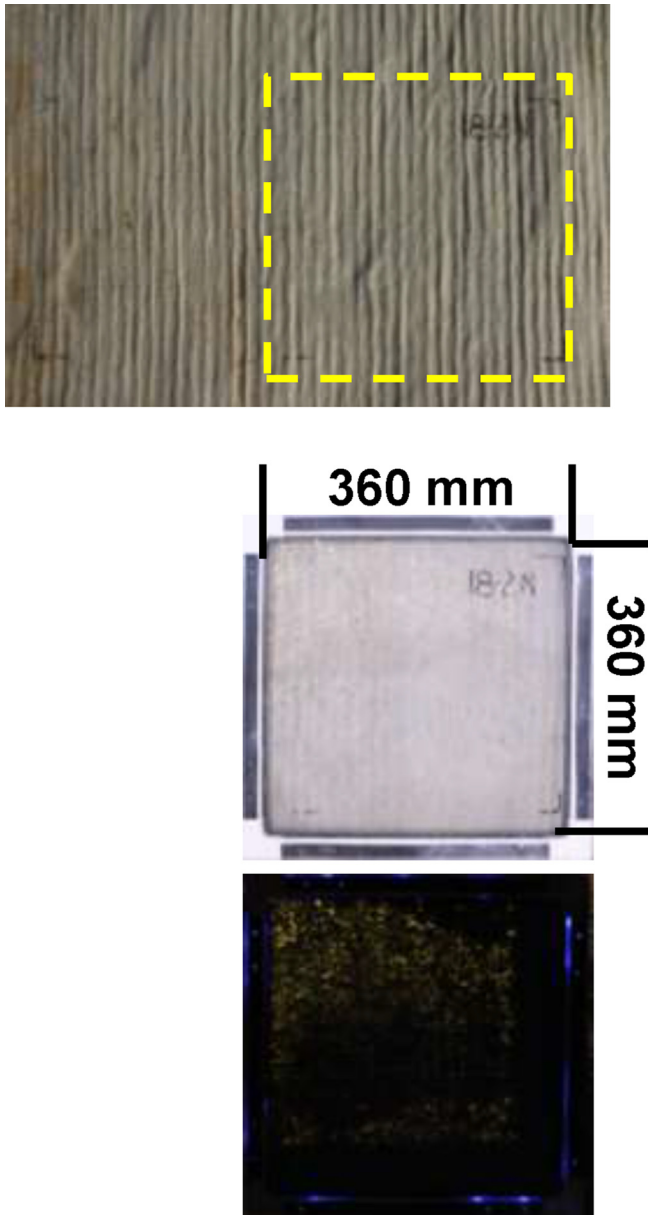
**Fig. 23.** No evidence of erosion on GCL8 beneath a black geomembrane after 28 months exposure (September 2014). Light panel photos show largely uniform desiccation cracking with very narrow openings that do not let significant light through; compared to the photos of other GCLs.

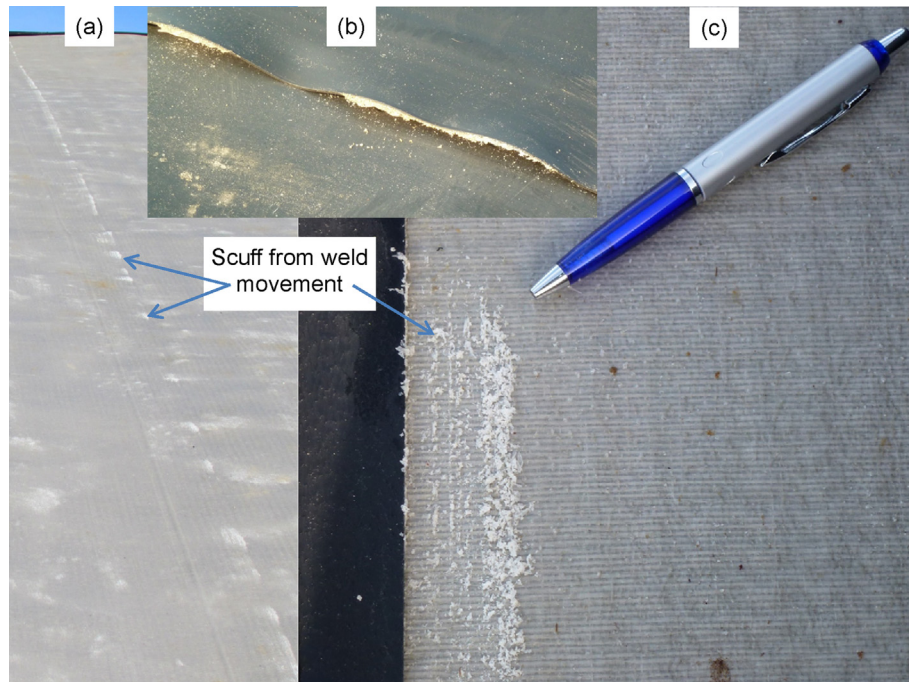
**Fig. 24.** Scuffing of the 100 µm polypropylene coating of GCL8 due to the movement of weld due to thermal expansion and contraction of the geomembrane: (a) scuffing of the GCL coating along almost entire weld, (b) coating material accumulated on the lower geomembrane overlap at the weld, and (c) polypropylene coating accumulated on weld overlap and scuffing of GCL.

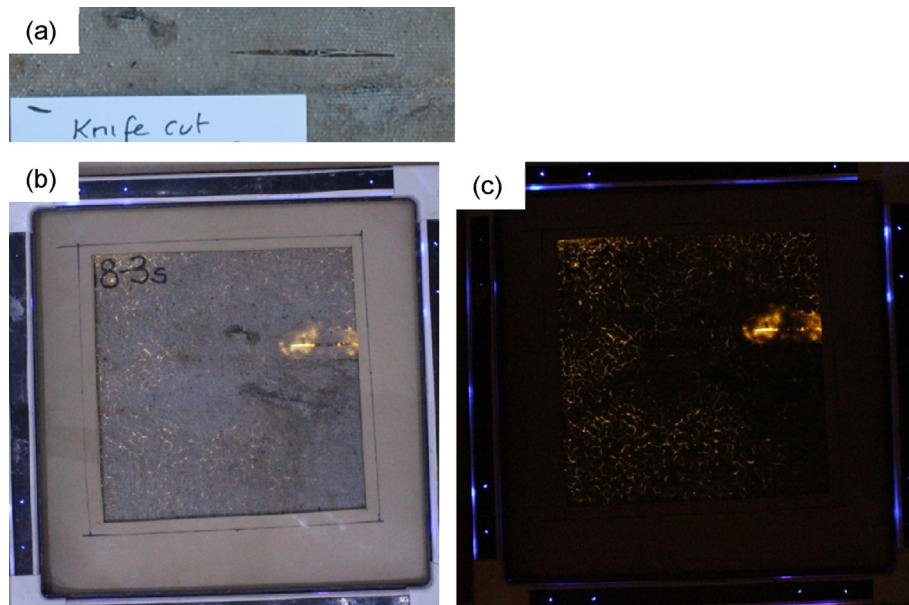
**Fig. 25.** Cut in coating of GCL8: (a) 70 mm knife cut, (b) darkroom photo with internal light on showing cut and bentonite loss around hole, and (c) darkroom photo with internal light off showing cut and bentonite loss around hole.

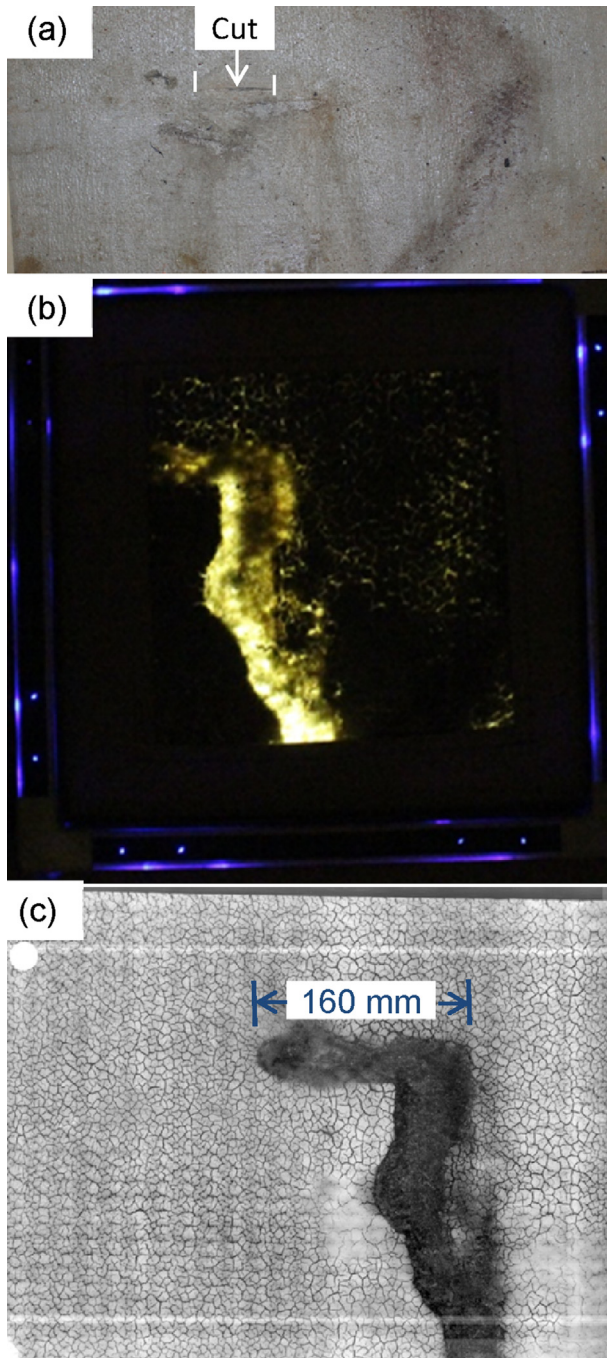
**Fig. 26.** Erosion feature (a) emanating from a cut in coating of GCL8, (b) darkroom photo with internal light off showing bentonite loss from below right side of hole (width of photo is 300 mm), and (c) X-ray photo showing bentonite loss at cut and below right side of hole (black area). Desiccation is visible elsewhere (short black matrix are desiccation cracks around white bentonite zones).

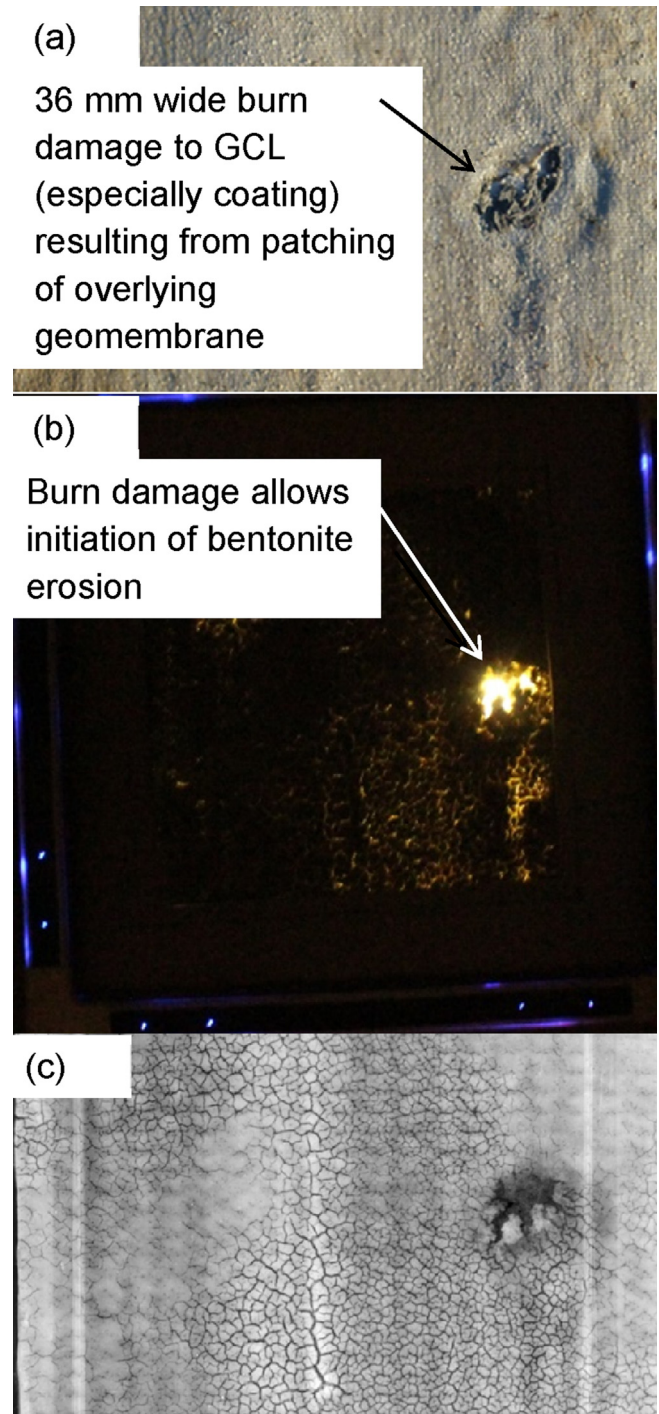
**Fig. 27.** Erosion feature (a) emanating from a burn in coating of GCL8 (width of photo is 300 mm), (b) Darkroom photo with internal light off showing bentonite loss from location of burn (width of photo is 300 mm), and (c) X-ray photo showing bentonite loss at burn (black area on right mid of photo).
