# Field and laboratory observations of down-slope bentonite migration in exposed composite liners<sup>☆</sup>

R. Kerry Rowe<sup>a,\*</sup>, Richard W.I. Brachman<sup>a,1</sup>, W. Andy Take<sup>a,2</sup>, Amy Rentz<sup>b</sup>, Lauren E. Ashe<sup>c</sup>

<sup>a</sup> GeoEngineering Centre at Queen's-RMC, Department of Civil Engineering, Queen's University, Kingston, ON, K7L 3N6, Canada

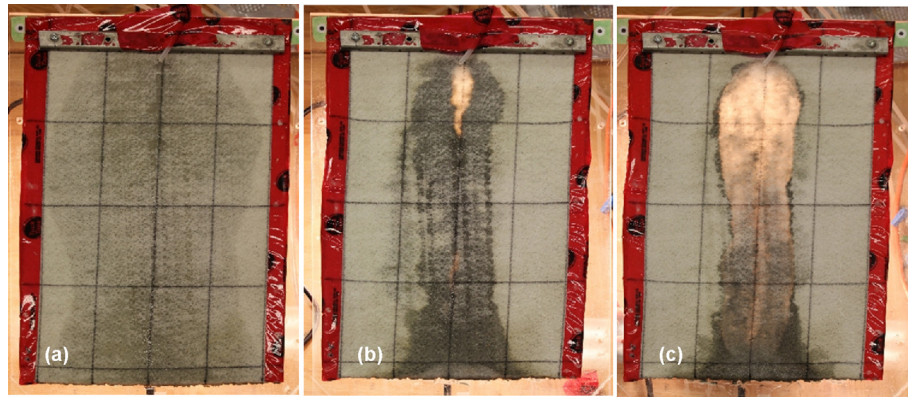
**Fig. 10.** Laboratory specimen of GCL2 photographed on inclined light table and photographed after: (a) Cycle 2, (b) development of first erosion hole, 'E', at Cycle 5, and (c) development of irrecoverable erosion, 'EE', at Cycle 11.

There is reason to suspect (Moreno et al., 2011) that when in contact with water of very low ionic strength, the repulsive forces between clay particles would make the bentonite particles more prone to being suspended and carried away with the flowing water than if the water had higher ionic strength. Indeed, as already discussed above, the flow of deionized water caused the development of an erosion hole ('e' or 'E' features) in typically 5–6 cycles (e.g., Fig. 10b). Once an erosion feature developed it rapidly grew to irrecoverable erosion ('EE'; with little or no bentonite over a width > 25 mm) after about 6–8 cycles and which extended from the top to bottom of the specimen after about 9–10 cycles (Fig. 10c shows an example after 11 cycles).

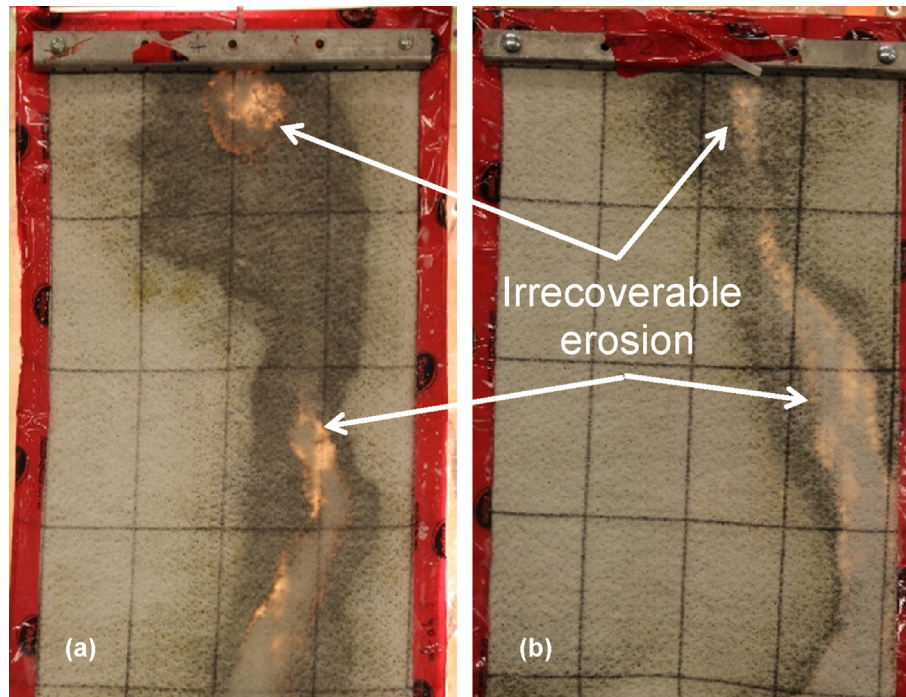
**Fig. 12.** Photographs of the hydration part of a cycle showing irrecoverable erosion features developed on slopes of: (a) 3H:1V (after Cycle 9), and (b) 33H:1V (after Cycle 15).

the 3% slope than on the 3H:1V slope. The progression from a first hole to significant irrecoverable erosion was slower on the base slope specimens due to a less concentrated and more variable flow path (again consistent with observations at QUELTS). For example, Fig. 12 shows irrecoverable erosion that has developed at Cycle 9 on the 3:1 slope and Cycle 15 on the 33H:1V slope.

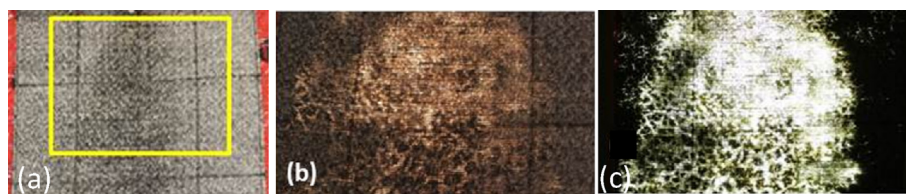
When GCL3 was tested with the black woven carrier geotextile up, the behaviour was similar to that for GCL1 with water flowing through the first hole and then preferentially through the nonwoven geotextile making the visual detection of the growth of the erosion features difficult. However, the black colour made the observation of erosion not only difficult in the field (as noted earlier) but also with a halogen backlight due to the absorption of light rays by the black geotextile. For both GCL3 and GCL4 with the black geotextiles facing up, erosion features that had formed were difficult, if not impossible, to detect visually with no back light. Even in normal daylight and a halogen backlight the erosion feature would not be noticed without very close inspection (Fig. 13a). From the distance at which the photo is taken (1 m above the GCL), all that is evident is the darker wet area where water had flowed over the past 8 h in this hydration cycle. The presence of irrecoverable erosion within the boxed area (width of box is 200 mm) is not apparent despite the halogen backlight which clearly showed erosion features of GCL2 or even GCL3 when the white nonwoven was placed up. When the boxed area in Fig. 13a is viewed much closer-up (0.3 m above the GCL; Fig. 13b) with the halogen backlight in normal daylight, light can be faintly seen in the eroded zone. Only when viewed in a dark room was the irrecoverable erosion feature clearly visible with the halogen backlight (Fig. 13c).

**Fig. 13.** GCL3 with black woven-up and irrecoverable erosion 'EE': (a) photographed with a halogen backlight in normal daylight, (b) close-up of 200 mm wide area inside box shown in Figure 13a photographed with halogen backlight in normal daylight, and (c) close-up of the same area as Figure 13b with the same halogen backlight but photographed in a dark room. The black areas in Figure 13c are where there is still a significant thickness of bentonite. Modified from Ashe et al. (2015).

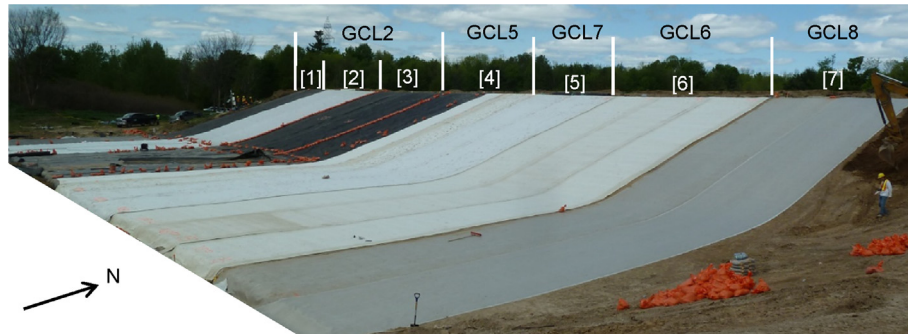
**Fig. 15.** QUELTS II during construction in May 2012. Textured 1.5 mm HDPE geomembrane was placed on the slope and a smooth geomembrane on the base. Sections from west to east (left to right): [1] GCL2 with 0.3 m gravel, [2] GCL2 with white GMB, [3] GCL2 (control; as per Section 3 of QUELTS I), [4] GCL5, [5] GCL7, [6] GCL6, and [7] GCL8 with polypropylene coating-up (Table 1).

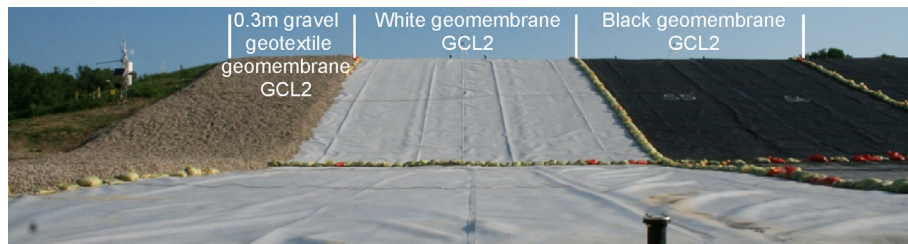
**Fig. 16.** Western three sections of QUELTS II viewed looking north. From west to east (left to right): [1] GCL2 covered by black geomembrane, geotextile protection layer, and 0.3 m gravel, [2] GCL2 covered by a white geomembrane, and [3] GCL2 covered by a black geomembrane.

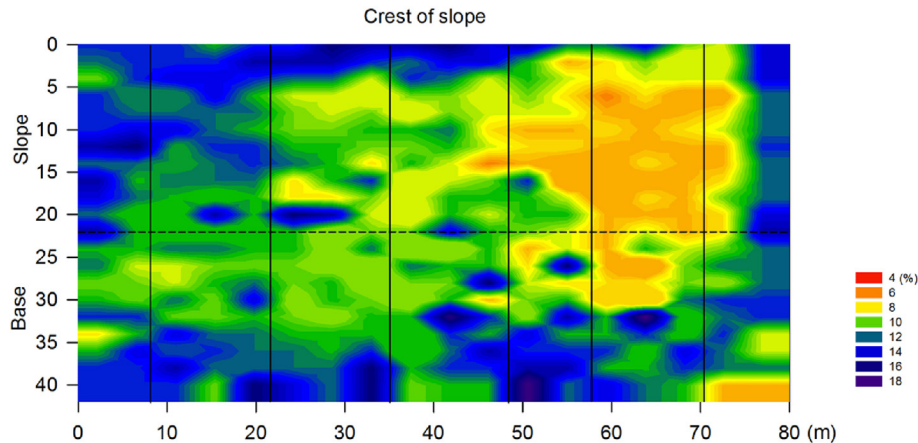
Fig. 17. Contour map of soil gravimetric water content (%) just prior to liner installation at QUELTS II (distances in m measured from top of slope (north) and east edge of base).

since this portion of the site was unlined for QUELTS I and added to the lined portion of QUELTS II, exposing the soil to precipitation prior to covering with liner material.
